**WALK BIKE
IRONDEQUOIT**

THOMAS AVE WALK/BIKE AUDIT REPORT

2025

Walk Bike Irondequoit
in partnership with the
Town of Irondequoit

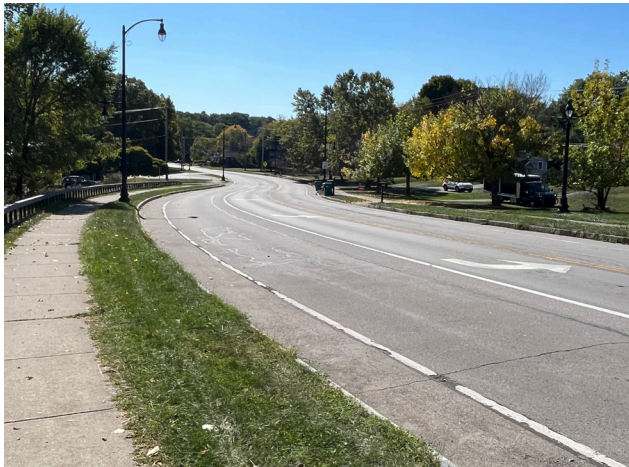
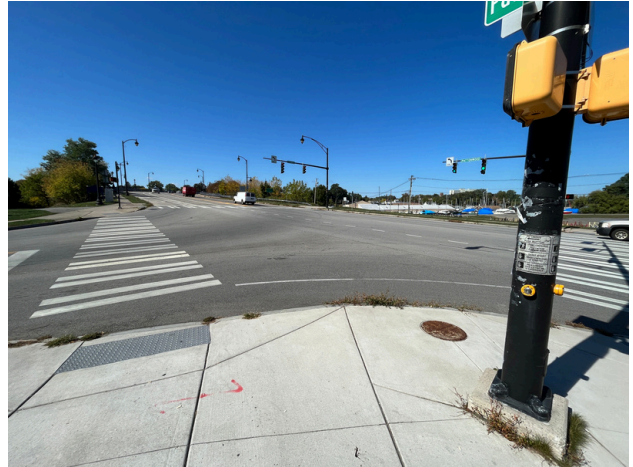
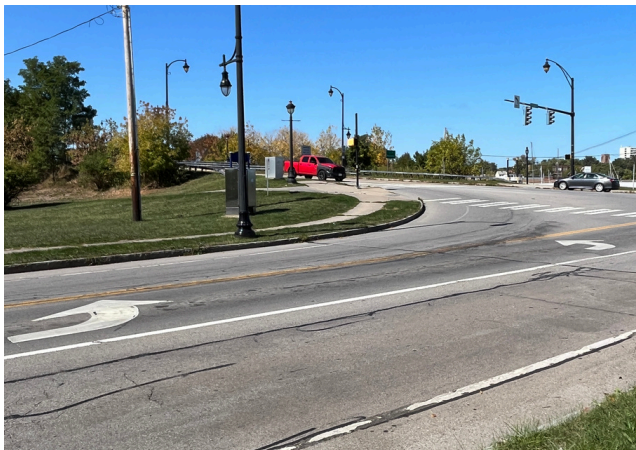
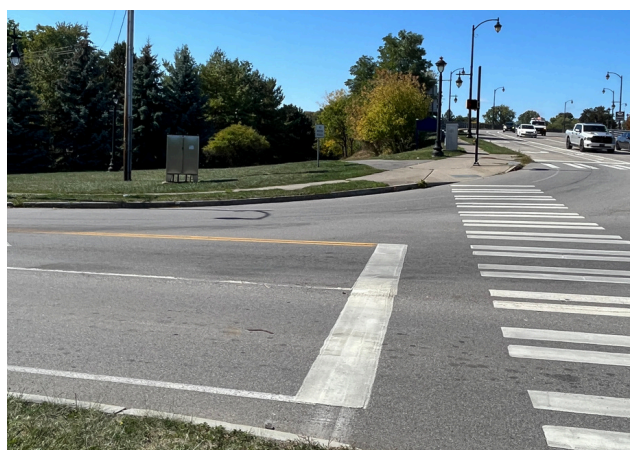
Major signalized intersection with fast-moving traffic and wide turning radii in all directions. Crosswalks are striped but span 3–4 lanes. A paved underpass allows for crossing underneath Pattonwood, but it is a lengthy detour.

- Fast turns from bridge and from Pattonwood onto Thomas, and Thomas onto Pattonwood
- No-turn-on-red signage absent
- Wide crossings feel unsafe to pedestrians
- Underpass with trail access is a long diversion for non-drivers

Thomas Ave at Pattonwood Dr looking south

Thomas Ave at Pattonwood Dr looking northwest

Thomas Ave at Pattonwood Dr looking north

- Install “No Turn on Red” signage
- Consider curb extensions or pedestrian refuges
- Improve visibility and pedestrian signal timing

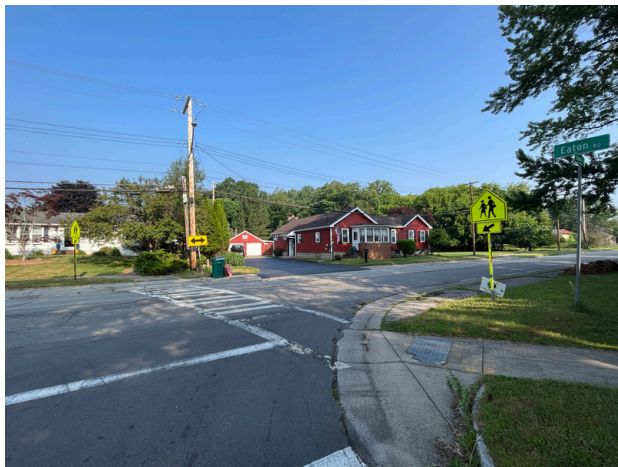
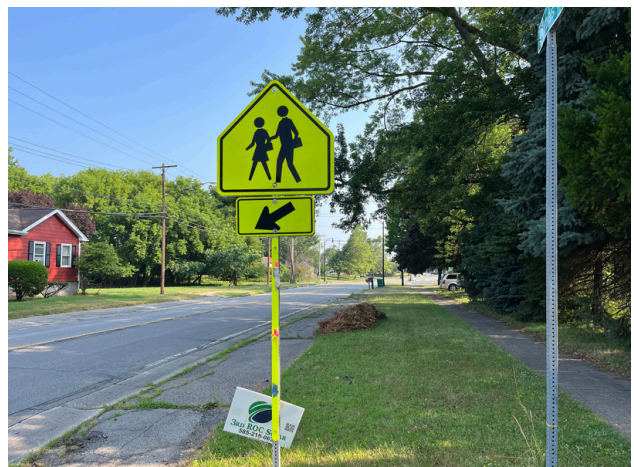
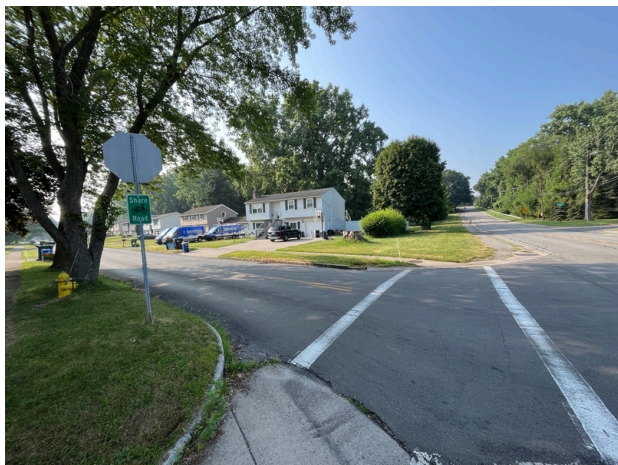
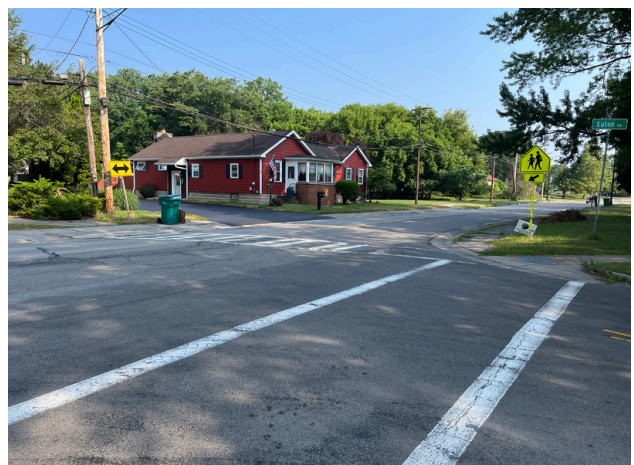
Unsignalized crossing with faded striping and limited ADA infrastructure. Bicycle route signage present. Wide grass buffer between narrow sidewalk and road. Fast traffic.

- No stoplight
- Missing tactile strip on south side
- Faded crosswalk striping
- Overhanging tree branches

Thomas Ave at Eaton Rd looking north

Thomas Ave at Eaton Rd looking south

- Install RRFB (as proposed by Monroe County)
- Add tactile curb ramps
- Repaint markings and trim vegetation
- Nearby trail connection opportunity to the Seneca Trail
- Wide shoulders could accommodate bike lanes

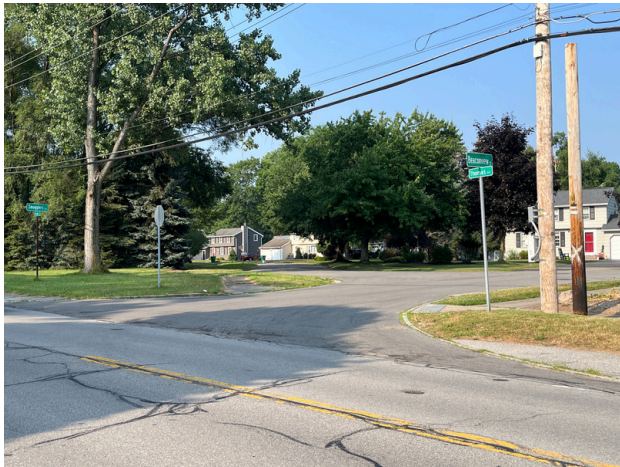
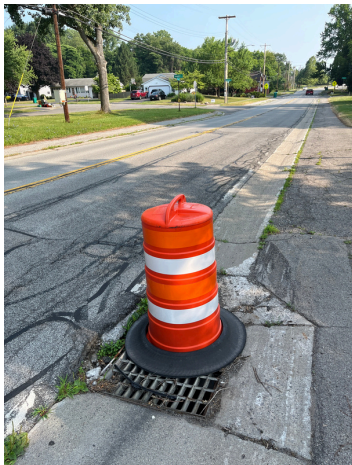
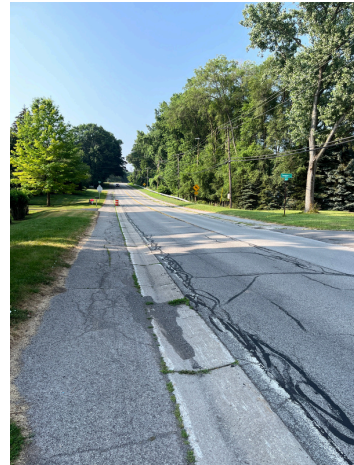
Residential loop intersections on west side of Thomas. No sidewalks, crosswalks or pedestrian striping present. Fast moving traffic approaching/coming from Pattonwood Drive. Constrained sightlines up Thomas to the south.

- No sidewalks or striping across Thomas, or Beacon View Court, or tactile strips
- Reported unsafe walking and crossing conditions due to speeding traffic
- Wildlife crossing sign present

Thomas Ave at Beaconview Court looking east

Thomas Ave at Beaconview Court looking north

Thomas Ave at Beaconview Court looking south

- Install sidewalks, and marked crosswalks
- Add ADA tactile curb ramps
- Add neighborhood traffic calming signage, or other traffic calming interventions

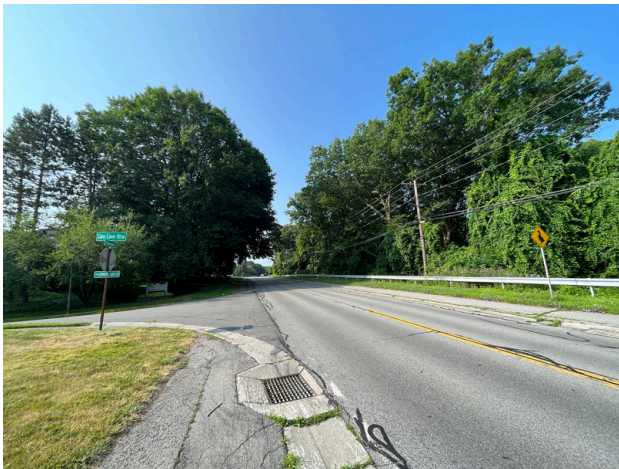
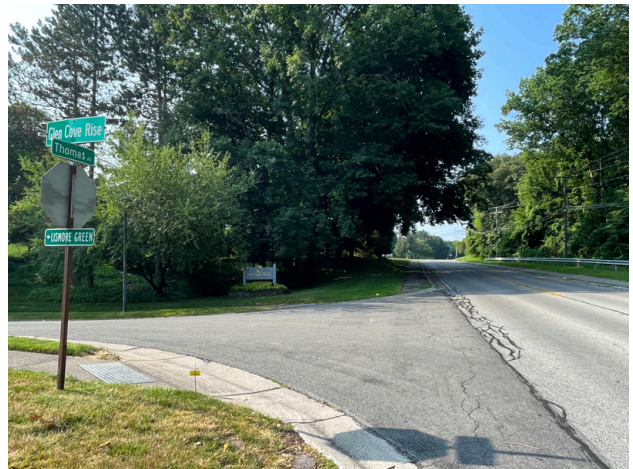
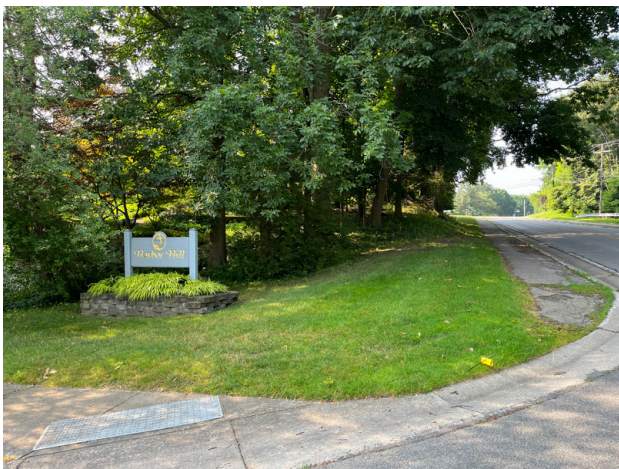
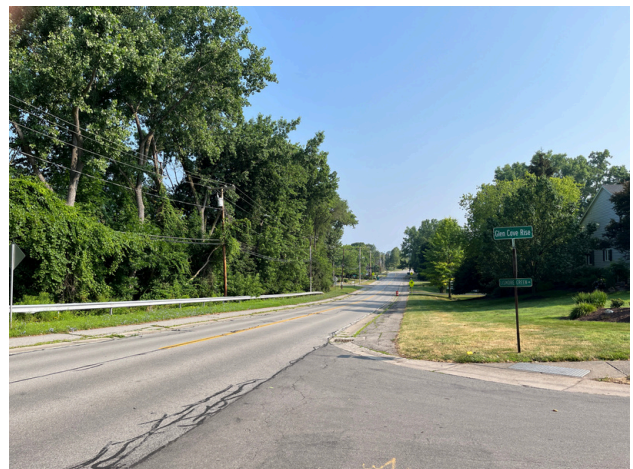
Located mid-corridor, Glen Cove Rise connects a cluster of homes with Thomas Ave. Intersection lacks sidewalk, crosswalks, curb ramps, and tactile strips. Paved shoulder and asphalt in poor condition in some places. Fast moving traffic.

- Wide turns encourage fast driving
- Lack of sidewalk leaves walkers, bikers and others feeling very exposed to danger
- Speeding observed

Thomas Ave at Glen Cove Rise looking south

Thomas Ave at Glen Cove Rise looking north

- Add sidewalk and high-visibility crosswalks
- Reduce turning radius
- Improve shoulder paving

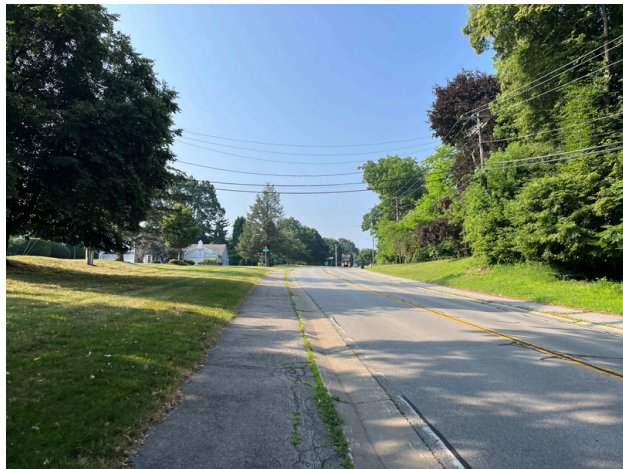
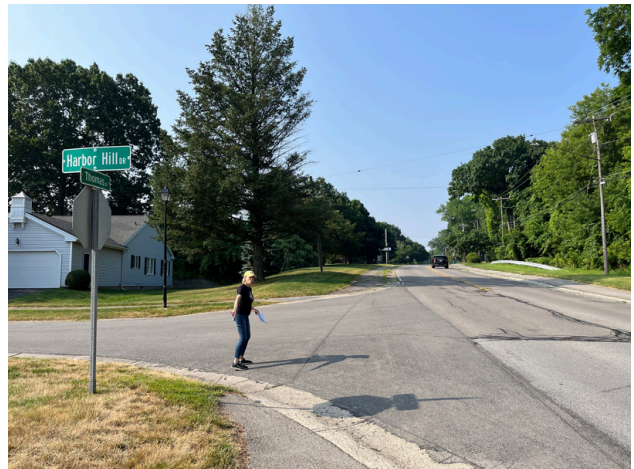
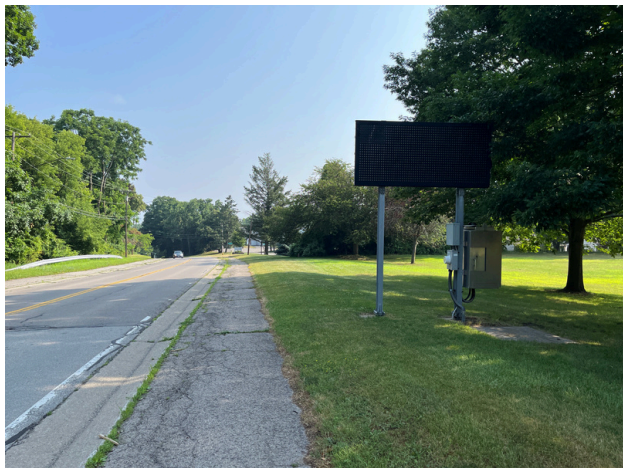
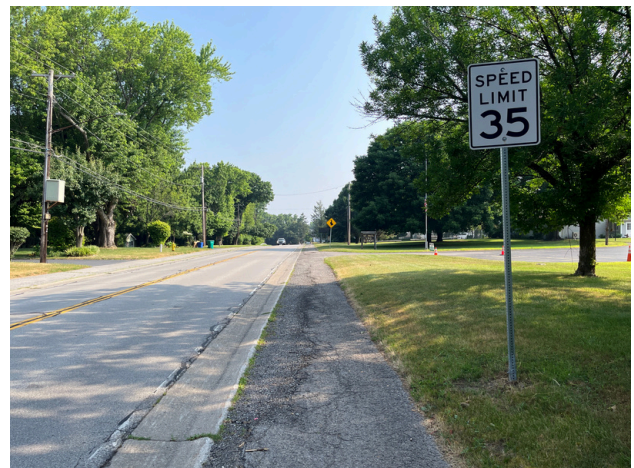
Located on a curved hill segment with limited visibility this intersection can be challenging for people walking or biking. Lacks sidewalk, crosswalk striping, ADA curb ramps and tactile strips. Wide turning radius.

- Wide, fast turns
- Missing tactile curb ramps
- Sloped approach complicates visibility and accessibility for mobility-impaired pedestrians, pedestrians, cyclists, and other users

Thomas Ave at Harbor Hill Rd looking south

Thomas Ave at Firemen's Exempt looking north

- Install sidewalk, crosswalk and curb ramps
- Add traffic calming features

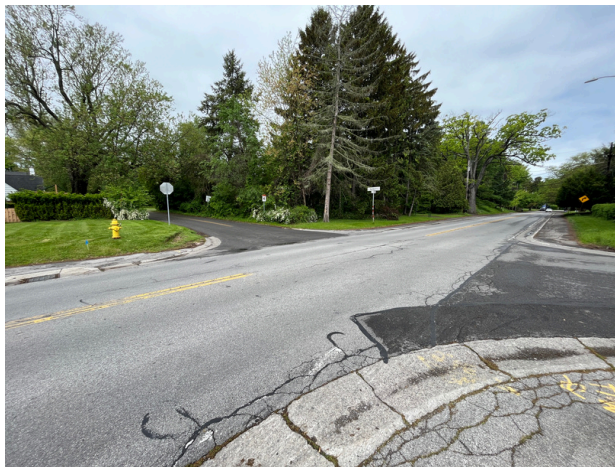
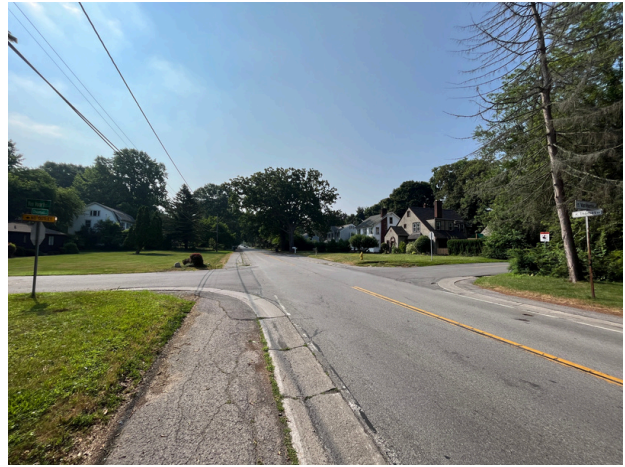
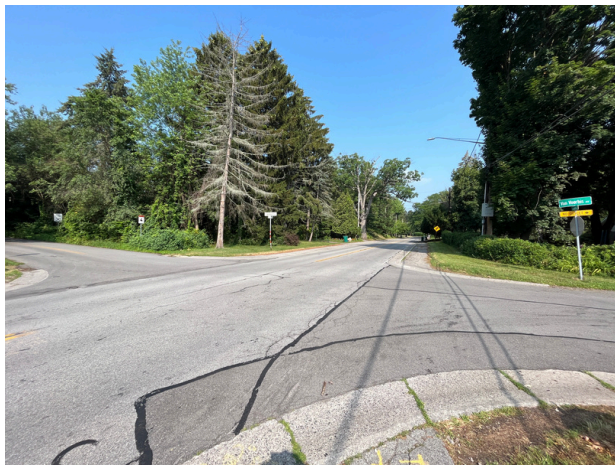
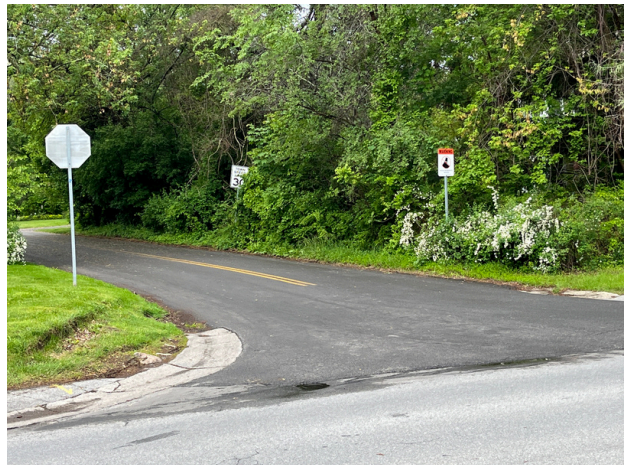
Four-way intersection with a narrow paved shoulder and no pedestrian striping in any direction. Overgrown vegetation impairs safe turning onto and from Thomas.

- No ADA curb ramps, tactile paving, or marked crossings
- Overgrown shrubbery impairs visibility
- Shoulder too narrow for mobility users on the west side of Thomas

Thomas Ave at Van Voorhis Ave looking north

Thomas Ave at Van Voorhis Ave looking south

Thomas Ave at Van Voorhis Ave looking west

- Add curb ramps and crosswalks
- Add pedestrian crossing signage
- Trim vegetation
- Rebuild or widen shoulders

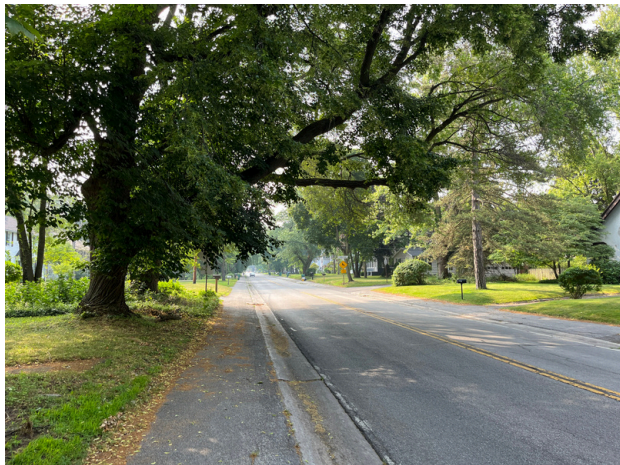
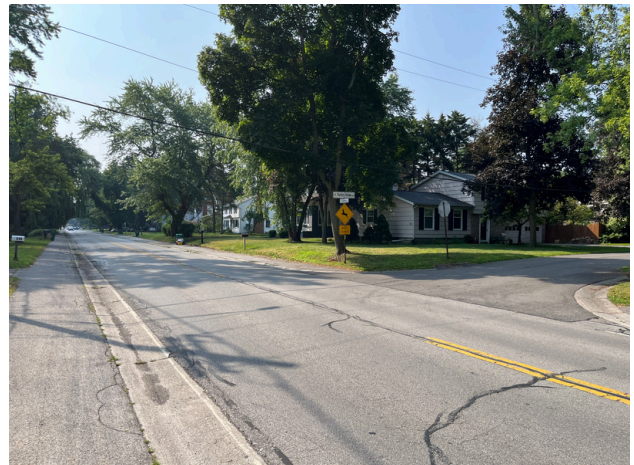
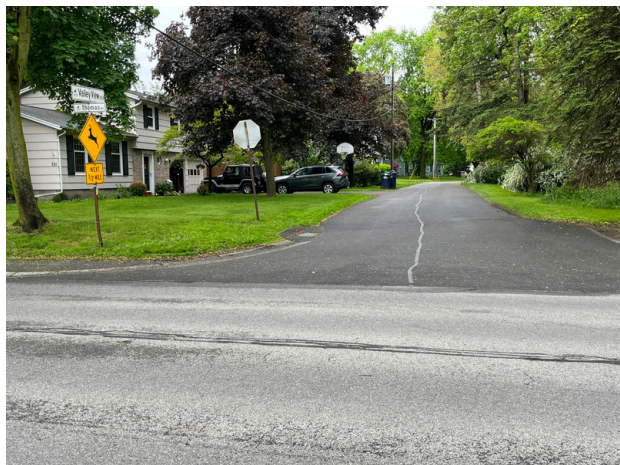
This residential crescent intersects Thomas Ave near a mid-block segment with moderate traffic speeds. Sidewalks are present but narrow and close to the travel lane. Crosswalks are absent, and roadside vegetation partially obstructs sightlines.

- Narrow sidewalk on east side with minimal buffer heightens stress for pedestrians
- Vegetation limits visibility of pedestrians entering/exiting the intersection
- Narrowing road geometry on Valley View Crescent when turning from Thomas
- Overhanging tree limbs encroach sidewalk/shoulder on Thomas
- Poor shoulder condition.

Thomas Ave near Valley View Crescent looking south

Thomas Ave at Valley View Crescent looking south

Thomas Ave at Valley View Crescent looking west

- Install pedestrian signage and crosswalk striping
- Schedule regular vegetation maintenance

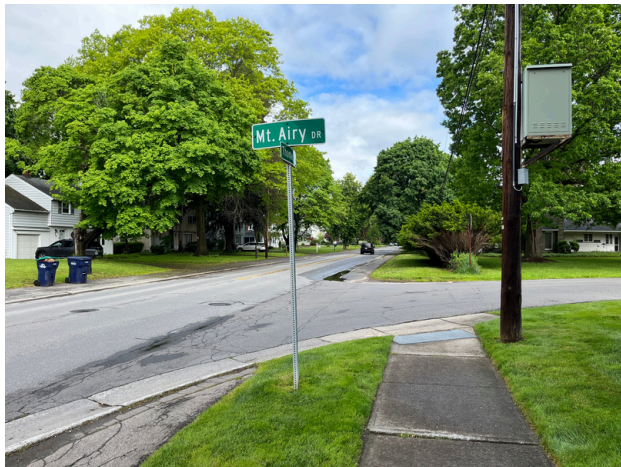
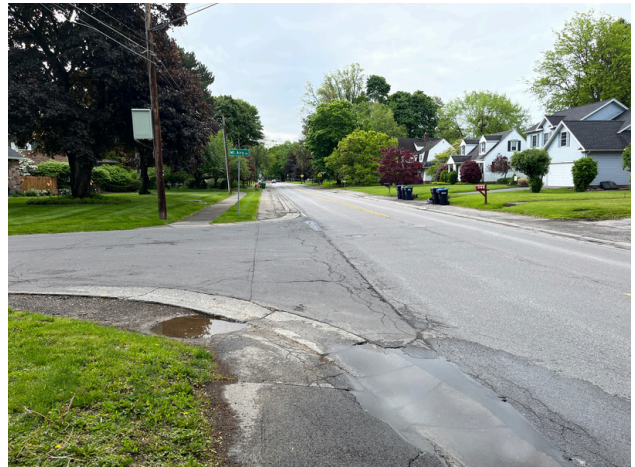
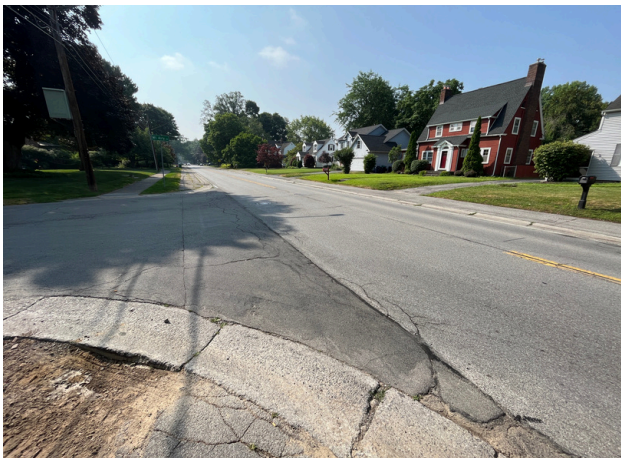
Wide turning geometry and poor pedestrian transitions. Lacks crosswalk. Tactile pad missing on north side of crossing.

- Sidewalk ends abruptly
- Very wide turning radii from Mount Airy onto Thomas
- No tactile paving on north side of crossing

Thomas Ave at Mt Airy Drive looking north

Thomas Ave at Mt Airy Drive looking south

- Complete sidewalk connection
- Narrow turning radius
- Install ADA curb ramps and crosswalk
- Prune vegetation

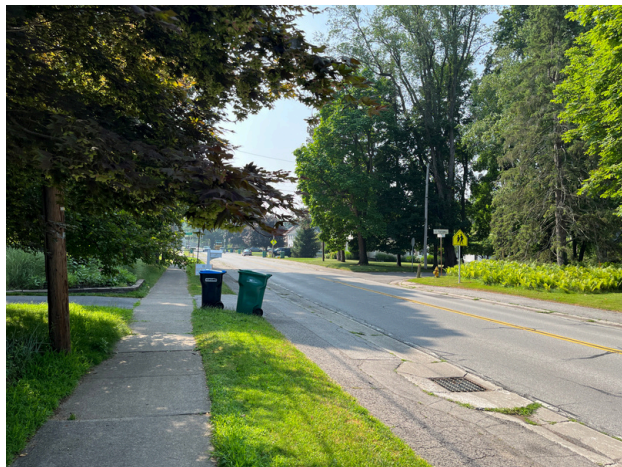
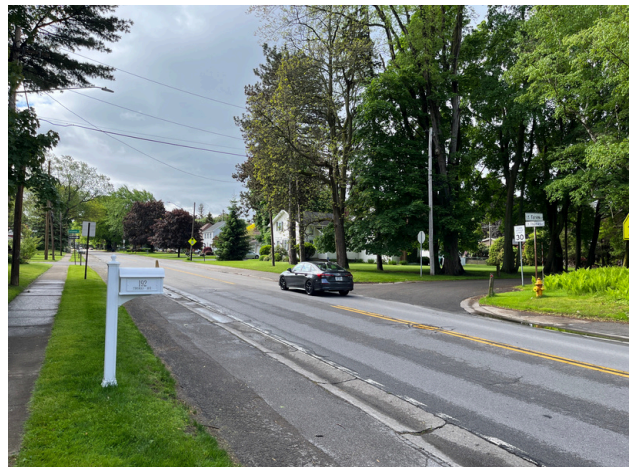
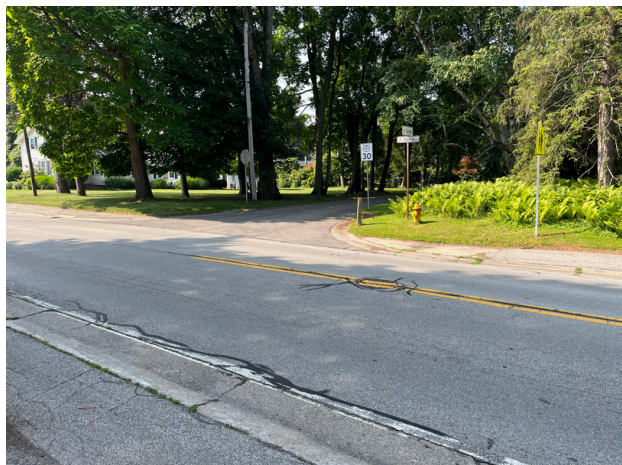
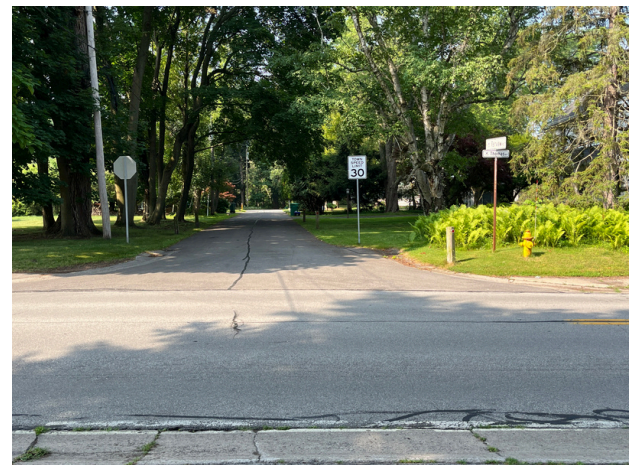
Narrow residential street intersects Thomas with awkward geometry. Lacks crosswalk.

- No crosswalks or tactile ramps
- One-directional signage only
- Difficult geometry for turning drivers

Thomas Ave near Fairview Rd looking south

Thomas Ave at Fairview Rd looking south

Thomas Ave at Fairview Rd looking west

- Consider one-way conversion
- Add pedestrian signage and striping
- Reconfigure curb geometry if feasible
- Add school zone markings

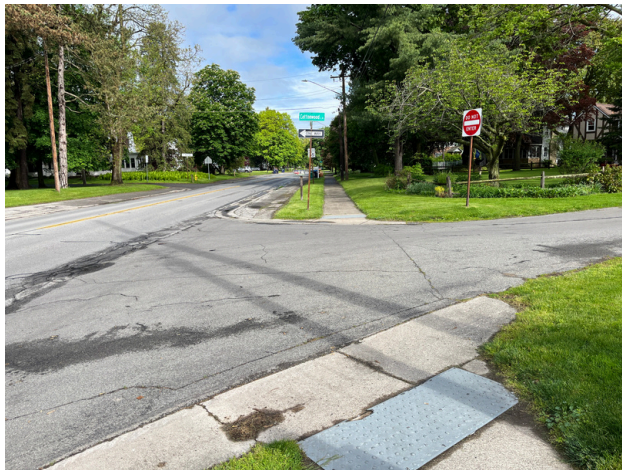
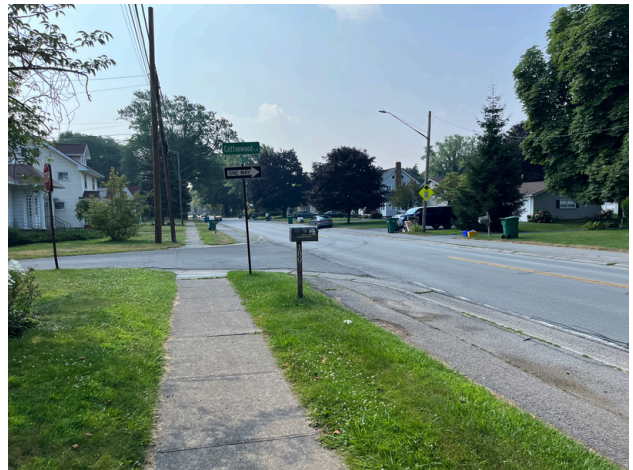
Meets Thomas Avenue as a one-way westbound street. Do Not Enter sign present. Tactile pads present but damaged. No crosswalk.

- Deteriorated tactile pads
- One-way entry
- No marked pedestrian crossing
- Wide turn radius promotes speeding
- Speed limit signage unclear or obscured

Thomas Ave at Cottonwood Lane looking south

Thomas Ave at Cottonwood Lane looking north

- Repair tactile pads
- Install crosswalk
- Reinforce 25 mph speed zone with signage

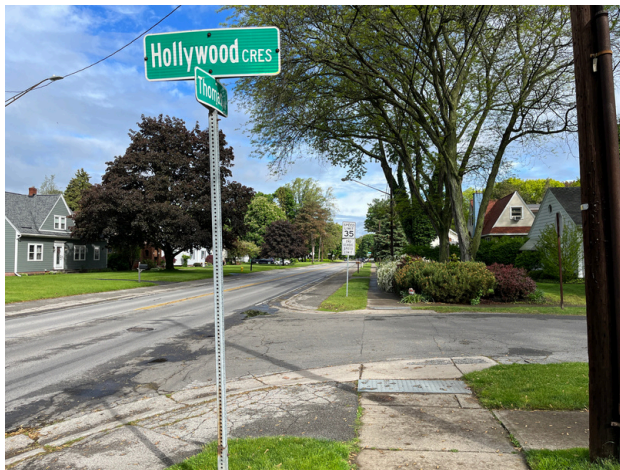
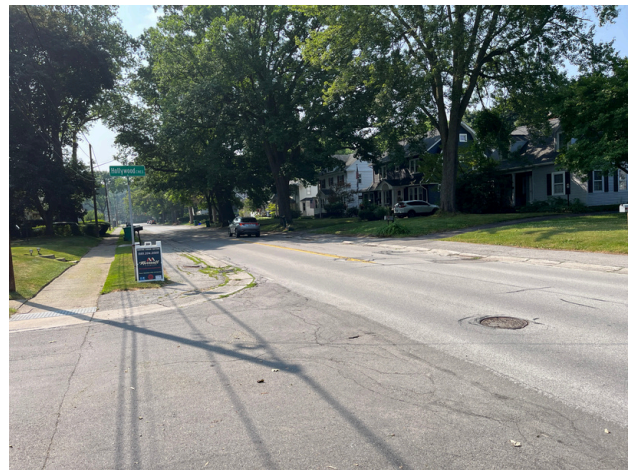
Located at the southern end of the Seneca School zone. Crosswalk striping needed. Tactile pads in poor condition. Wide turning radii.

- Inconsistent sidewalk and shoulder quality
- Poor condition of ADA features
- Weak visual cues for crossing in or near school zone

Thomas Ave at Hollywood Crescent looking north

Thomas Ave at Hollywood Crescent looking south

- Paint crosswalk striping
- Replace tactile surfaces
- Improve signage and traffic calming features near school
- Coordinate with WICSD crossing guard program.

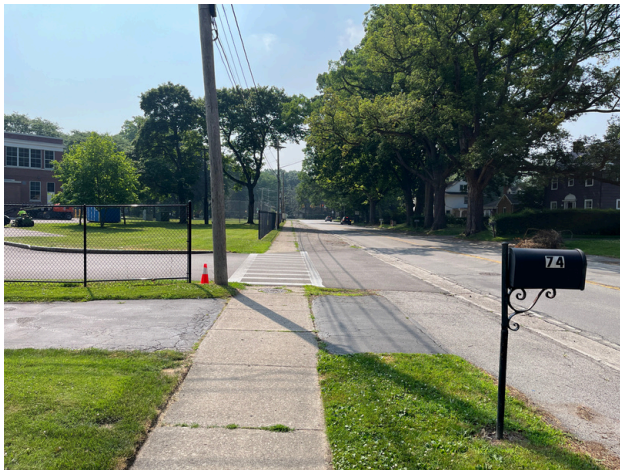
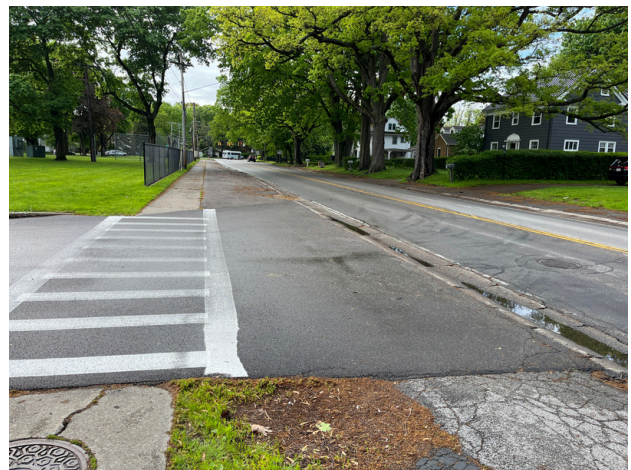
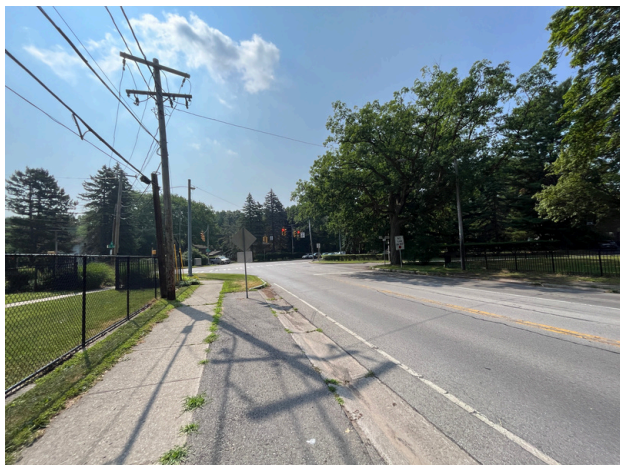
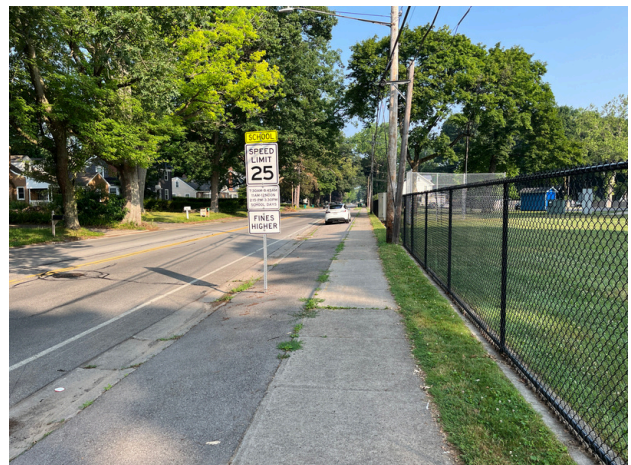
Located adjacent to the Seneca School zone. Crosswalk markings faded. Sidewalks present on one side but in mixed condition. Paved, slanted curb area is used for parking, and school pick-ups. Speed feedback signage present on Thomas headed north towards the school zone. Curb ramps exist but lack tactile pads.

- Vehicles often exceed posted speeds (~35 mph) despite proximity to school
- School zone signage lacks strong visual cues (no flashing beacons)
- Pick-up/drop-off activity creates conflicts between cars, pedestrians, and cyclists
- No dedicated bike infrastructure; students riding bikes must share roadway or sidewalks

Thomas Ave at Seneca School looking south

Thomas Ave at Seneca School looking north

- Repaint crosswalk striping with high-visibility markings
- Upgrade tactile surfaces to meet ADA standards
- Enhance school zone visibility with flashing beacons, signage, or painted road surface treatments
- Implement traffic calming (e.g., raised crosswalks)

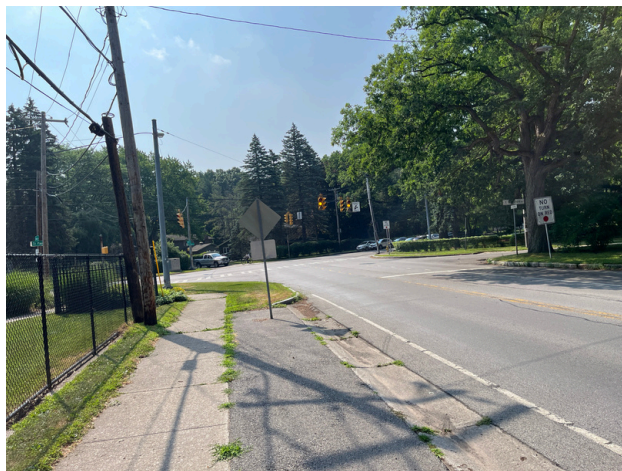
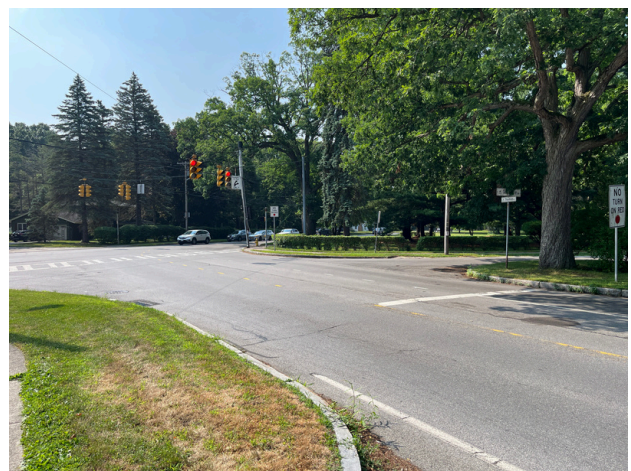
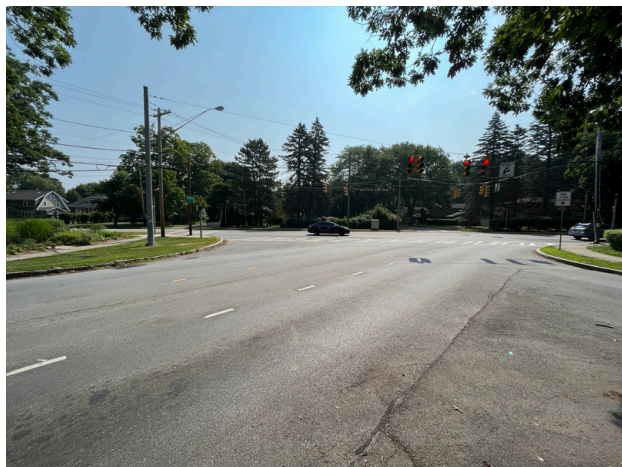
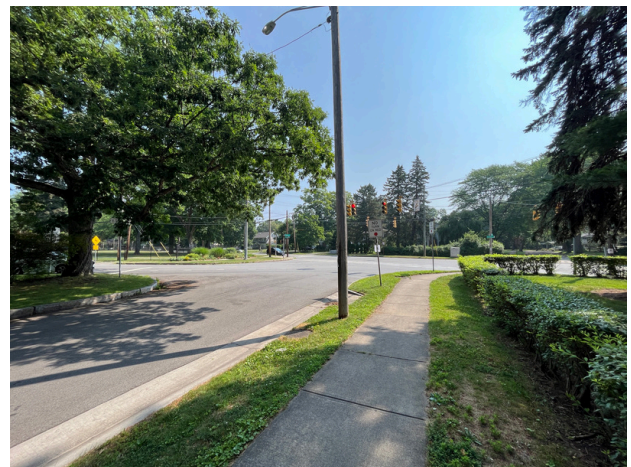
Complex, high-volume, signalized 5-way intersection serving multiple routes and the entrance to Seneca School. Very long, exposed crosswalk across Thomas/Sagamore. Crossing guard present at peak times across Thomas and St. Paul.

- Incomplete crossings (e.g., no striping across Sagamore)
- Confusing lane setup, signals, signage and multi-lane turns
- Traffic light trip signal emerging from Sagamore is too narrow-focused
- Two right-turn lanes from Thomas onto St Paul create driver competition and risk
- Heavy foot, bike traffic during school hours

Thomas Ave at St Paul Blvd looking south

Sagamore Dr at St Paul Blvd looking east

- Complete pedestrian crossings in all directions
- Add "Yield to Pedestrians" and "Turn Guidance" signage
- Retain and support crossing guard role
- Consider adding secondary school crossings
- Enact geometric reconfiguration
